RIDE QUALITY

Case Study: Boston Luxury Condominium

A Luxury Condominium In Boston

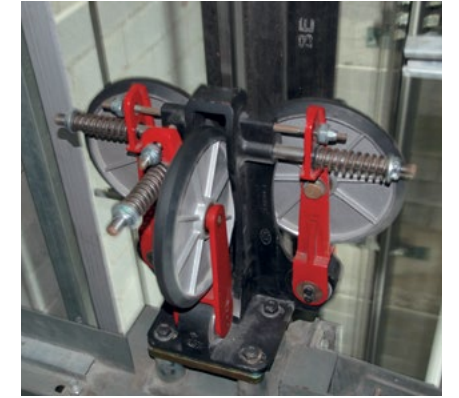
ELSCO proposed replacement of the existing roller guides with ELSCO Express-3 roller guides. Express-3 roller guides incorporate patented, shock-absorbing elastomeric pivot bushings, 10-inch (254 mm) neoprene roller wheels, and high-quality construction to dramatically reduce the effects of misaligned rails – at a fraction of the cost of rail re-alignment. Furthermore, the simple mounting and comprehensive instructions included with all ELSCO roller guides make for quick and painless installation. Contractor and consultant agreed to try ELSCO Express-3 roller guides, and together with ELSCO technicians, they took ride quality readings to measure the results.
